Icom 746 Pro Sudden Death Club Fix

A good friend asked me to look at his Icom IC-746PRO which suddenly stopped transmitting. I didn't know where to begin until I found a WEALTH of information on the Internet about other hams who have experienced the same fate!

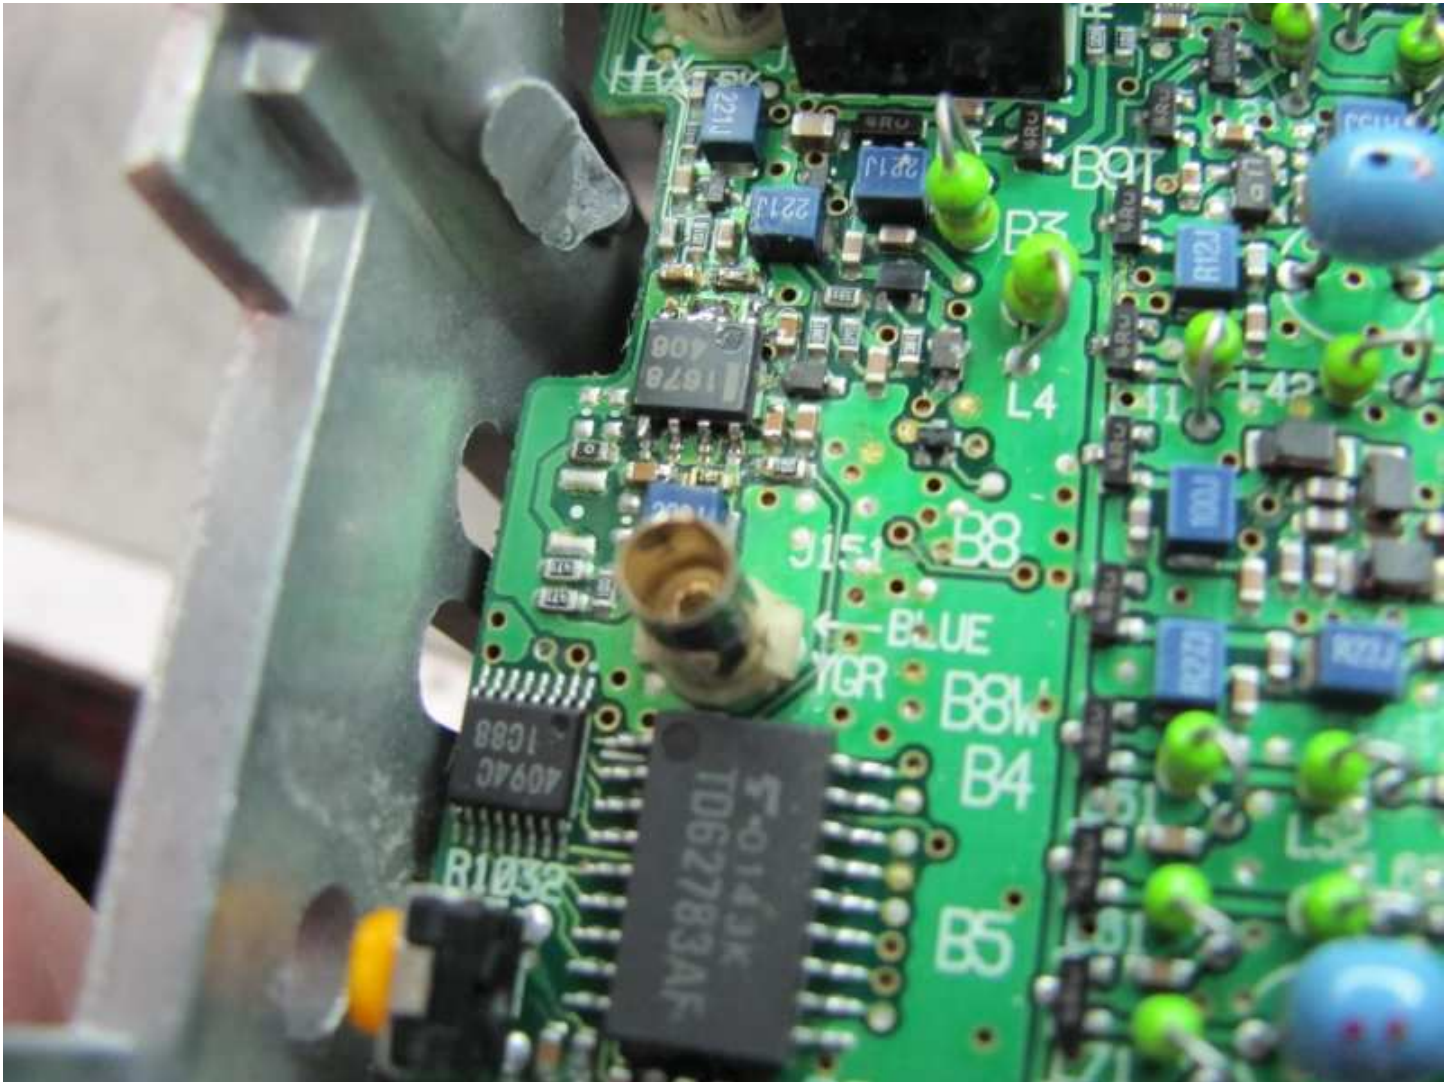
It was time to get to work on the 746PRO.

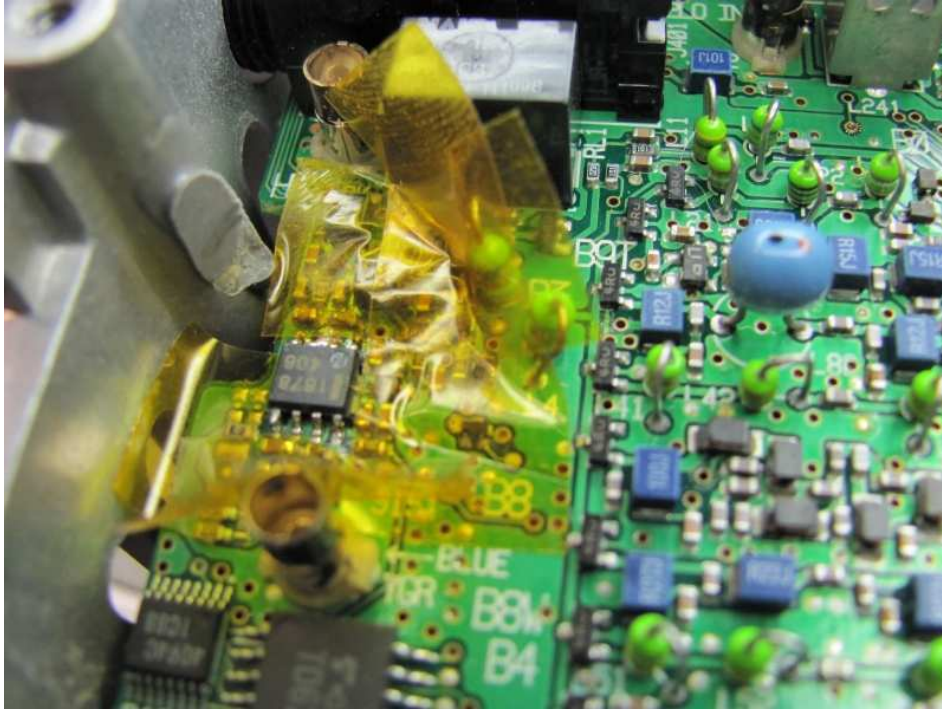
When I opened the radio, I found a big HEATSINK on IC-151. However, they forgot to add Heat sink compound and the Heat sink was not TOUCHING the IC!! A lot of good that did!! I removed the heat sink.

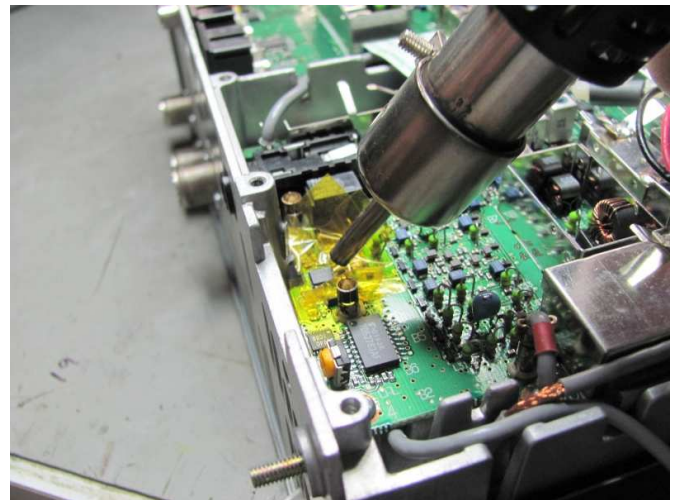
It was time to remove the IC, but we don't want to bother the other delicate components around the chip, so they are masked off with KAPTON TAPE. This deflects the heat and only the IC will be heated.

The device to remove the IC without endangering the pads is a hot air machine. It directs a pinpoint stream of heated air at the IC pins and melts the solder

Here we are heating the IC. It only took a few seconds before I could flick off the IC from the pads, leaving none damaged. The remaining solder was wicked off.

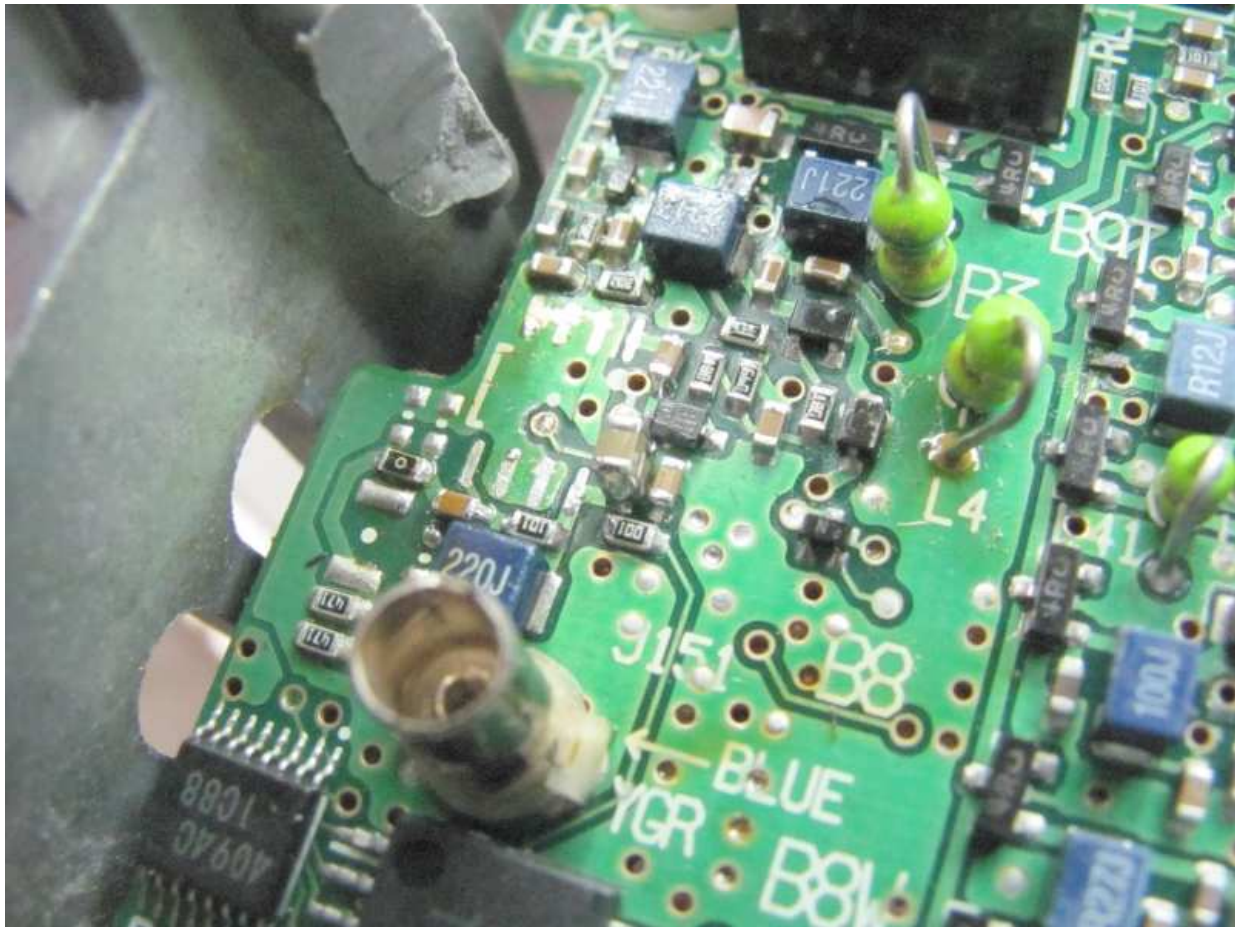
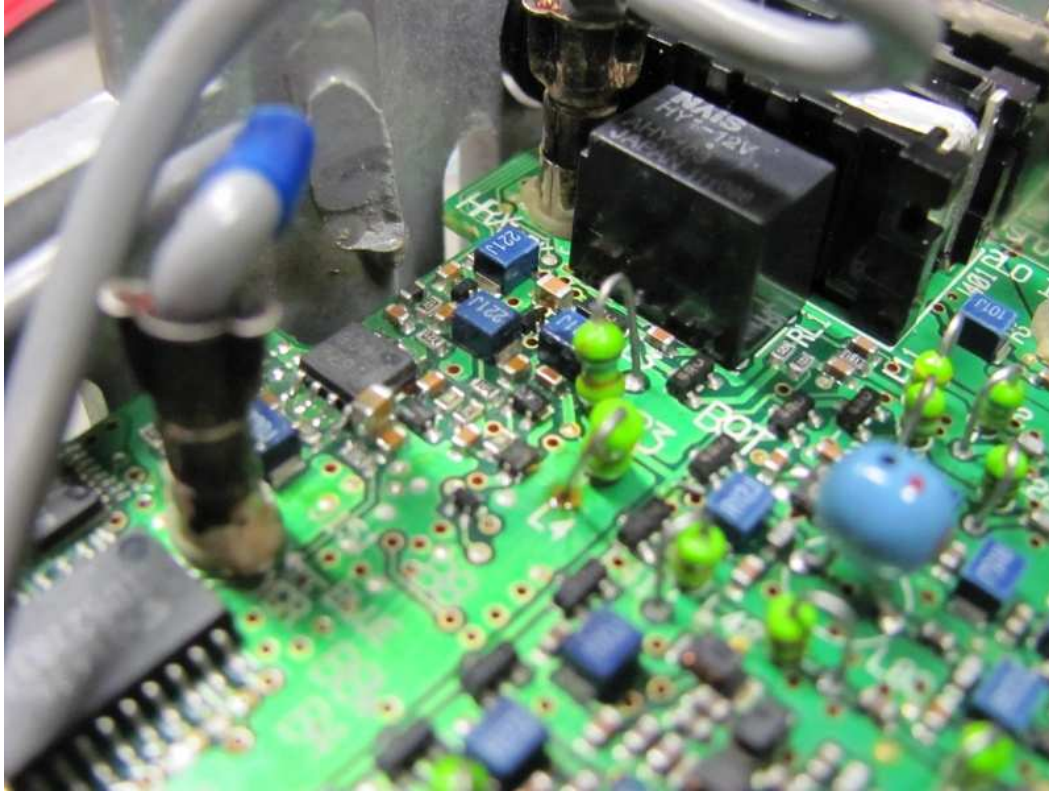
Now that the IC was off, the PCB was removed so I could install a couple of protection diodes on the back side. Then, on the top side, I installed 2 10uF caps where C156 was giving me 20uF of capacitance. You can see them just to the right of the IC pads.

So, in conclusion, all Icom owners of 746Pros are running on BORROWED TIME. It is not a matter of IF your IC-151 will blow, but a matter of WHEN. I suggest installing the C-156 mod of 2 10uF 603 or 805 sized caps in place of the existing 4700 pF! Now your 746PRO can run forever with NO DANGER to IC-151.

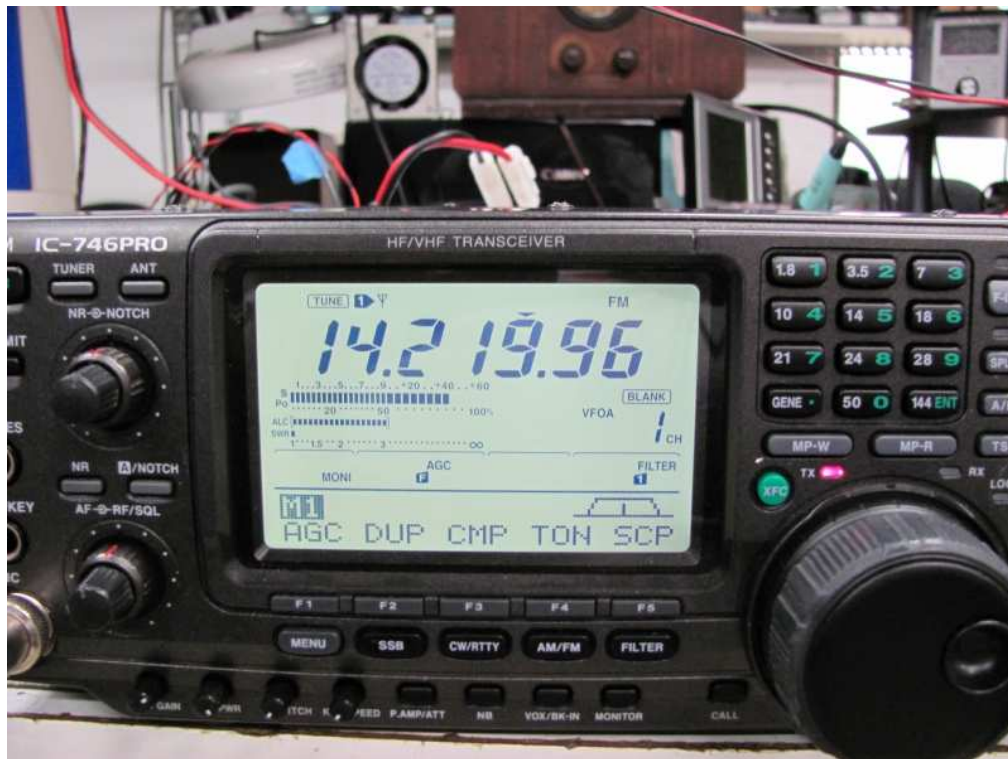
The IC arrived from Icom by Saturday FEDEX delivery, and I was ready to install it. It was soldered in and all voltages tested.

With my O-Scope, I monitored pin 8 and 5 of the IC. I turned the power on and off and saw NO SPIKES now. It was time to test the radio

To my great delight, the radio put out full output! IT was FIXED!!! I tested the radio with my finger on the IC to see if there was any warming. NONE WHATSOEVER, so the heat sink was NOT installed. All the articles saying to add the heat sink are a waste of time. The IC does NOT get hot!!! It gets ZAPPED and that is why they are blowing!!!
